TECHNICAL SERVICE BULLETIN

Ting, Pop Or Clicking Noise From The Front Or Rear Wheel Hub When Accelerating Or Applying Brakes (Torque Reversals)

22-2395

Ford 2022-2023 F-150 Lightning
--

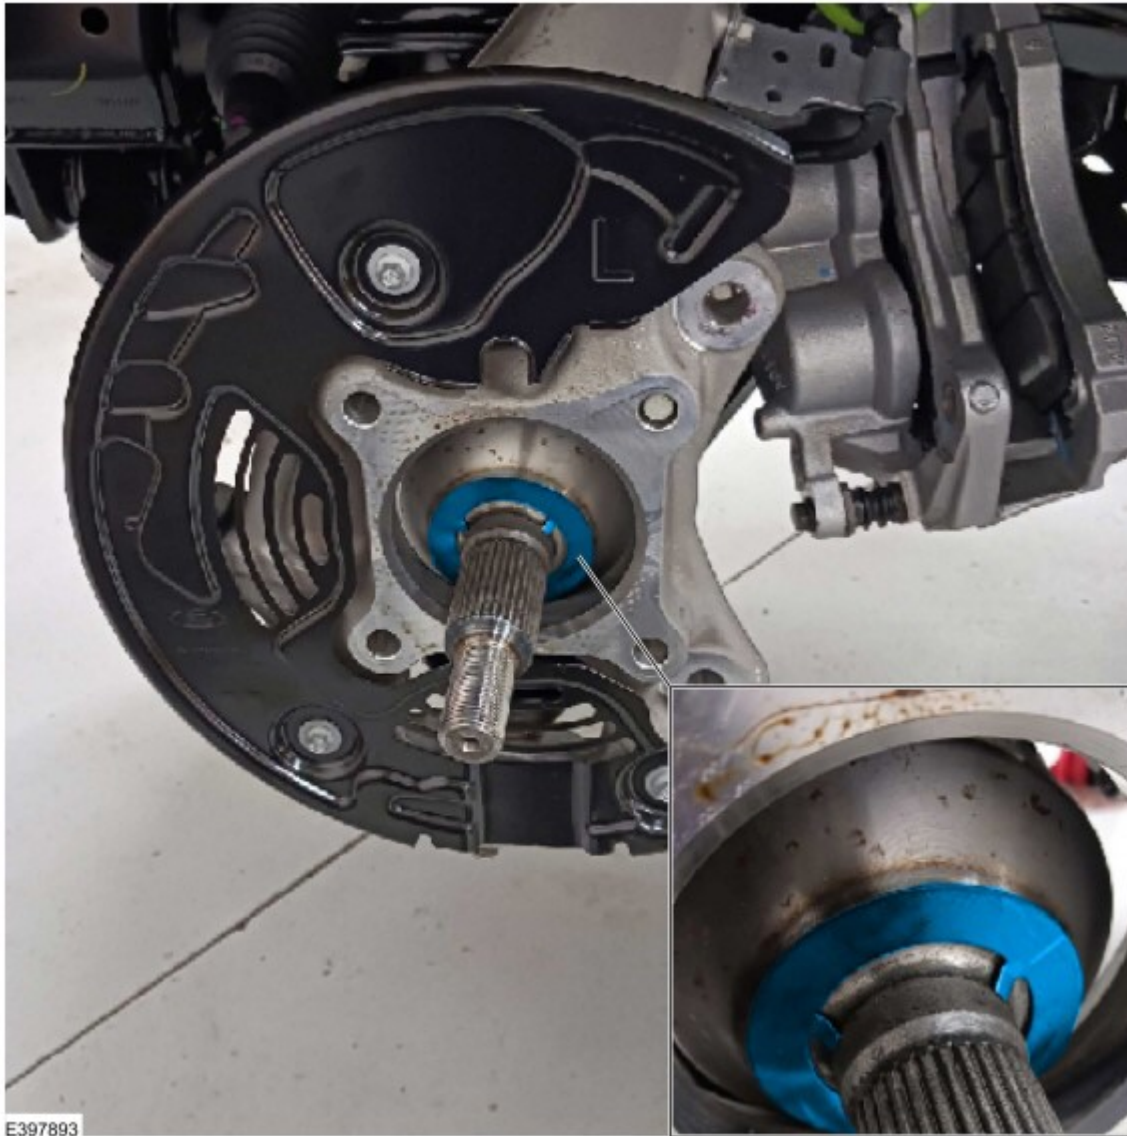
Figure 1

Issue: Some 2022-2023 F-150 Lightning vehicles may exhibit a ting, pop or clicking noise from the front or rear wheel hub when accelerating or applying brakes or when shifting between drive/reverse (torque reversals). This condition may be caused by stick/slip between the hub and halfshaft interface, during the torque reversals creating the ting/pop or clicking noise. To correct the condition, follow the Service Procedure to install the new anti-ting washer between the wheel hub and axle shaft.

1. Drive the vehicle to verify the concern, accelerate/apply brakes or shift from forward to reverse (torque reversals).
2. Does the vehicle exhibit ting, pop or clicking noise from the front or rear?
 - (1). Yes - add the anti-ting washer to both left and right halfshaft to hub interface for front and/or rear of the vehicle that exhibits the noise. (Figure 1)
Refer to the Workshop Manual (WSM) 204-02 Rear Suspension - Wheel Bearing and Wheel Hub > Electric Procedure or WSM 204-01B Front Wheel Bearing and Wheel Hub. Install the anti-ting washer between the wheel hub and axle shaft interface and reassemble.
